TECHNICAL NOTE 3847

FATIGUE-CRACK-PROPAGATION AND RESIDUAL-STATIC-STRENGTH  
RESULTS ON FULL-SCALE TRANSPORT-AIRPLANE WINGS

By Richard E. Whaley, M. J. McGuigan, Jr.,  
and D. F. Bryan

Langley Aeronautical Laboratory  
Langley Field, Va.

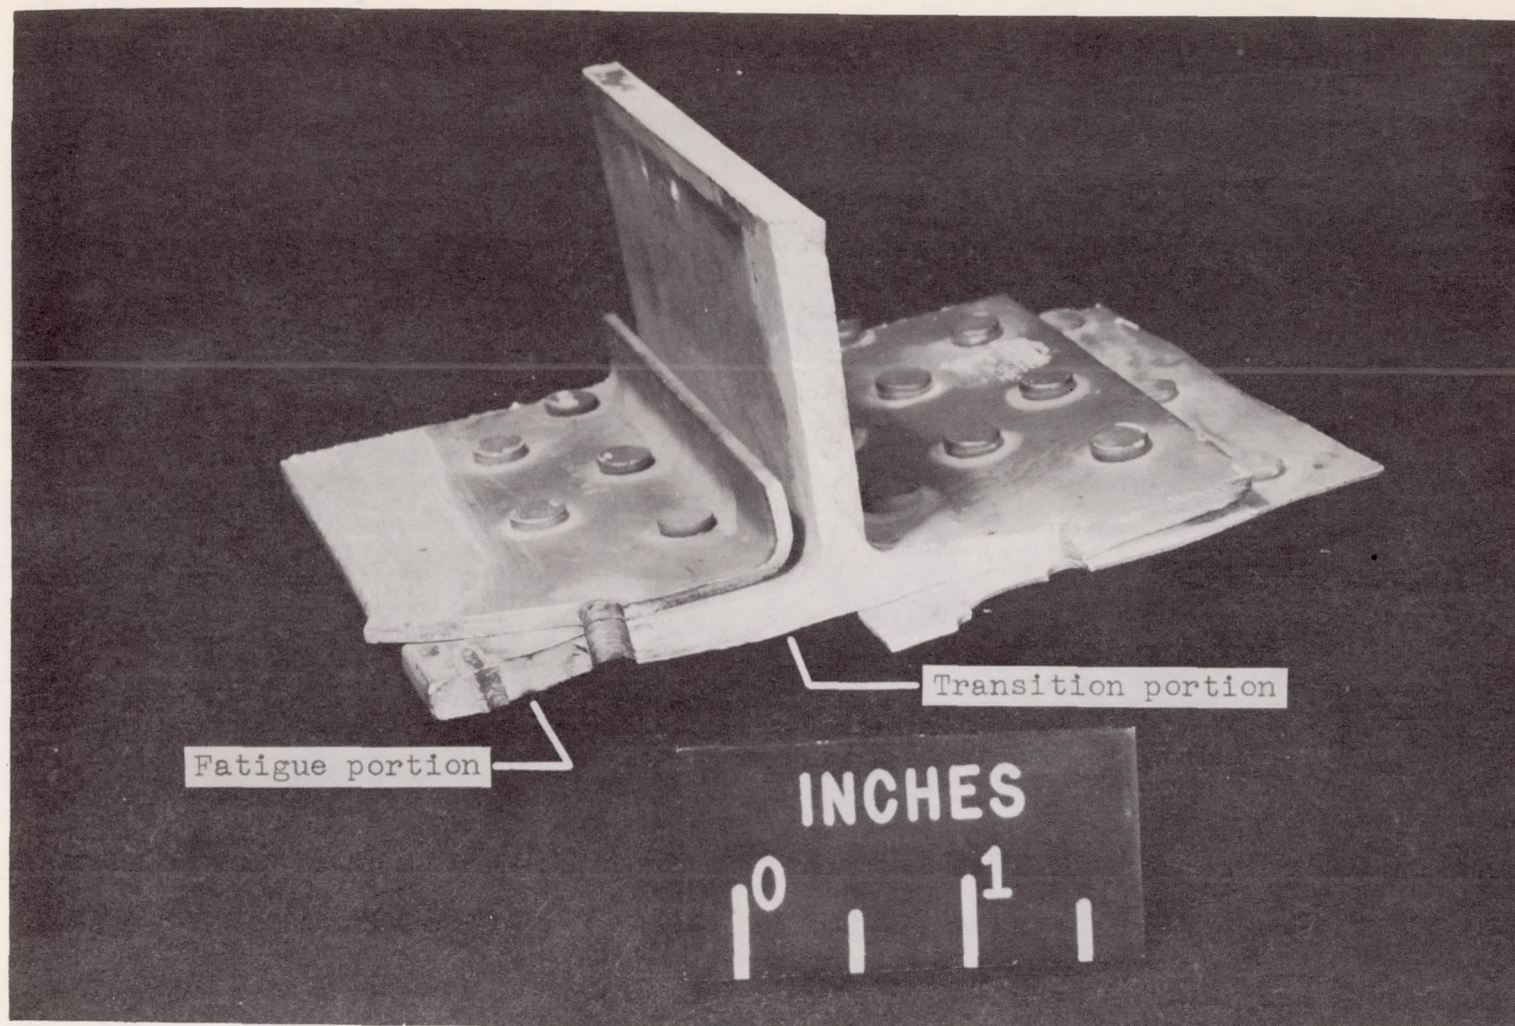
Figure 16.- Typical fractured surface.

Generally, the failure of most of the elements started as a fatigue type and then changed to the transition type. An example of this is shown in figure 16(a). At all load levels after the critical point had been passed, the failures were mostly of the transition type (see fig. 16(b)). For comparative purposes a purely static failure is shown in figure 16(c). Most of the failures did not exhibit all of the identifying characteristics enumerated, and some would be difficult to classify if it were not known beforehand which type of failure had occurred.

(a) Failure starting as fatigue type and changing to transition type. L-90899.1

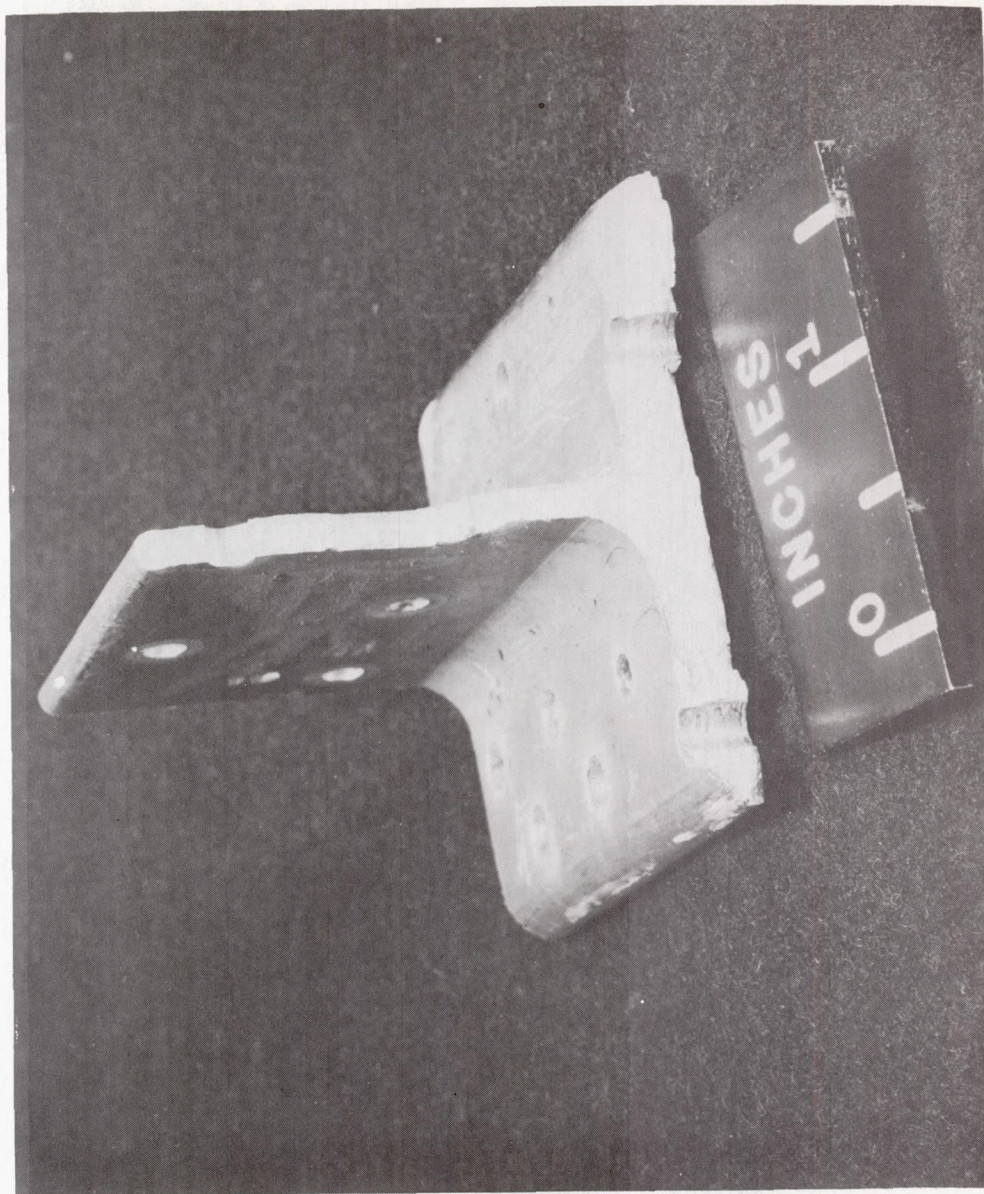
Figure 16.- Continued.

Description of failed surfaces.- Three different types of failures occurred. These three types were (1) true fatigue failure, (2) the static type of failure, and (3) a transition type between these other two types. The true fatigue failure exhibited several identifying characteristics which were as follows: (1) slow growth of the crack (2) fractured surface normal to the principal stress in the member involved, (3) no "necking down" of the element at the fracture, (4) a smoother texture of the fractured surface, (5) concentric rings or radial marks emanating from the nucleus of the fatigue failure, and (6) some residue from fretting corrosion was frequently present. The static failure of elements was, of course, abrupt and had the following characteristics: (1) the fractured surface was along the usual  $45^{\circ}$  shear plane and a feather edge was produced at the fracture, (2) necking down of the material, (3) the texture of the fractured surface was somewhat rougher and had a duller appearance than the fatigue failure. The transition type of failure progressed at a more rapid rate than the fatigue failure. The fractured surface of the larger elements was usually normal to the principal stress, but the appearance and texture of the fractured surface were more like the texture of the static failure than that of the fatigue failure.

(b) Transition type failure.

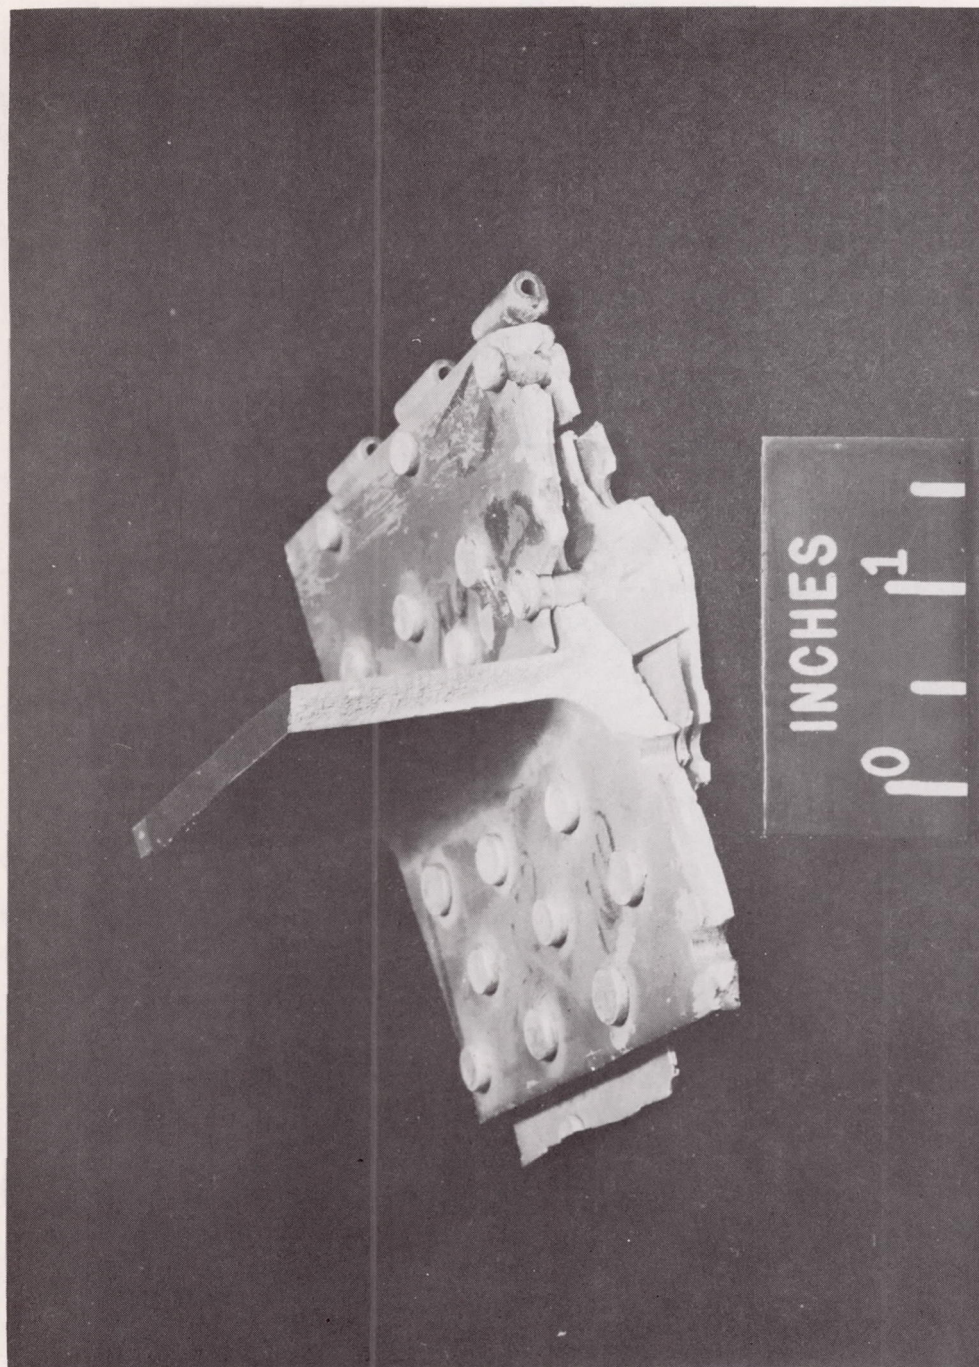
(c) Static type failure.
